Manhole Inspection Summary

Manhole # S45A__044MH

Insp Date: **6/13/08 8:43 AM**

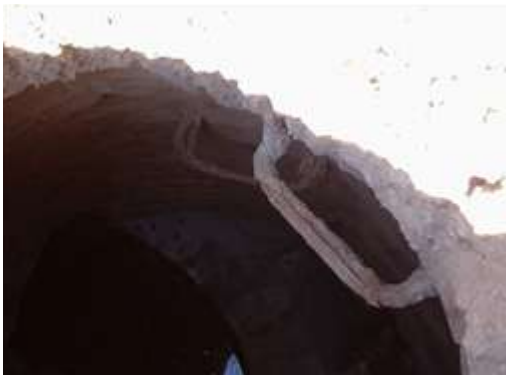
Defect 1

Count: **3** Missing: **0** ☒ **Corroded**

Corroded Steps

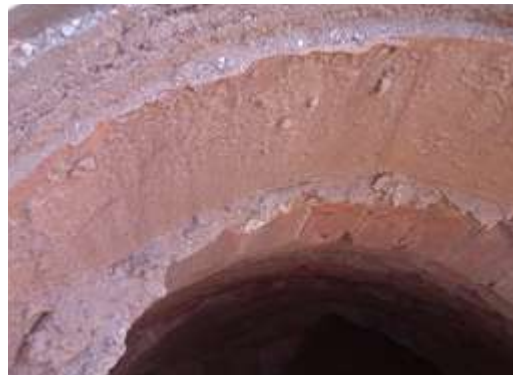
Defect 2

Infiltration: ☐ None ☒ **Joint** ☐ Cracks ☐ Mortar ☐ Roots ☐ Wall

Adjustment Joint

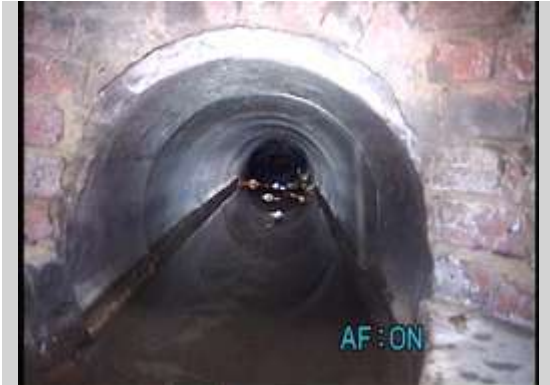
12 O'Clock Outflow

21 in. Circular Gravity Sewer
Pipe Out @ 12 O'Clock

Pipe Height: **21.6** (in.) Rod and Bar (Angled)
Pipe Material: **Clay** ☐ Pipe Lined
Invert Depth: **6.80** (ft.) Flow Characteristics: **Slow**
Deposits: ☒ None ☐ Mud ☐ Sludge ☐ Debris ☐ Grease
Silt Depth: (in.) Deposits Extent:
Infiltration: **None** Pipe Seal Cond: **Sound**

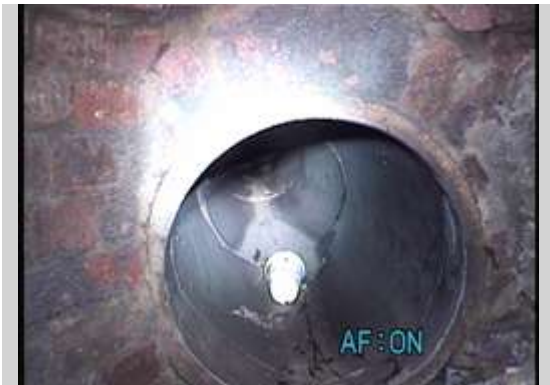
8 O'Clock Inflow

15 in. Circular Gravity Sewer
Pipe In @ 8 O'Clock

Pipe Height: **15.6** (in.) Rod and Bar (Angled)
Pipe Material: **Clay** ☐ Pipe Lined
Invert Depth: **6.00** (ft.) Flow Characteristics: **None**
Deposits: ☒ None ☐ Mud ☐ Sludge ☐ Debris ☐ Grease
Silt Depth: (in.) Deposits Extent:
Infiltration: **None** Pipe Seal Cond: **Sound**

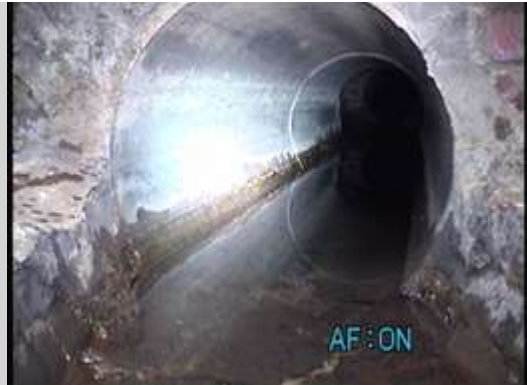
9 O'Clock Inflow

18 in. Circular Gravity Sewer
Pipe In @ 9 O'Clock

Pipe Height: **18** (in.) Rod and Bar (Angled)

Infiltration: **None**

Pipe Seal Cond: **Sound**
